CERTIFICATE OF APPROPRIATENESS

Property: 600 Avondale Street, Lot 5, Tract 4, Block 6, Montrose Subdivision. The property includes a historic two-story brick and wood frame single-family residence and a detached garage apartment situated on a 9,750 square foot (75' x 130') interior lot.

Proposal: Alteration – Windows

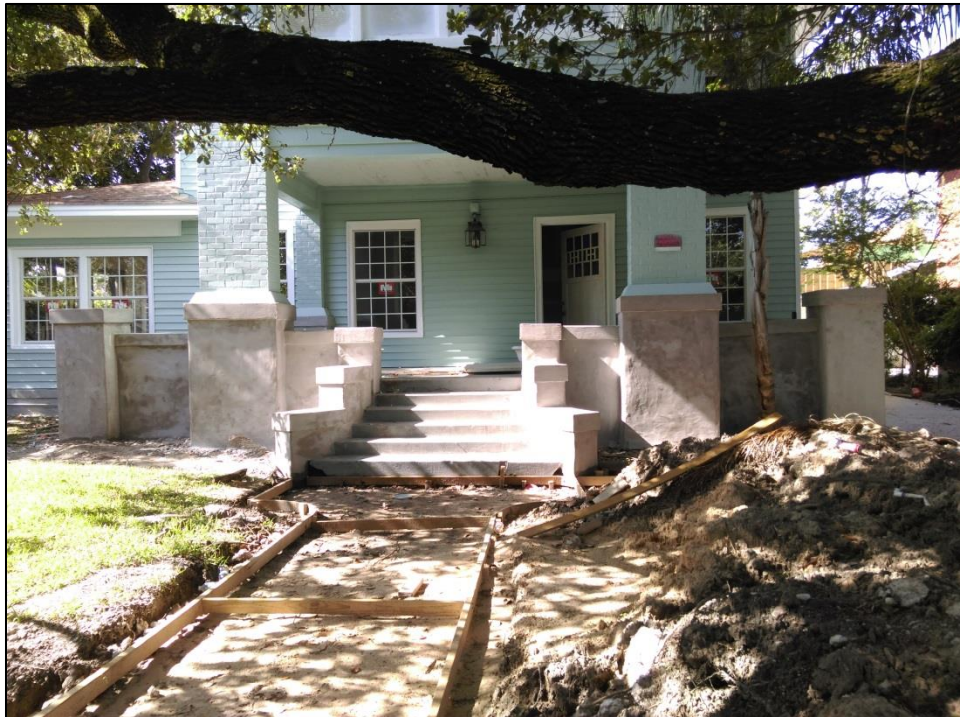
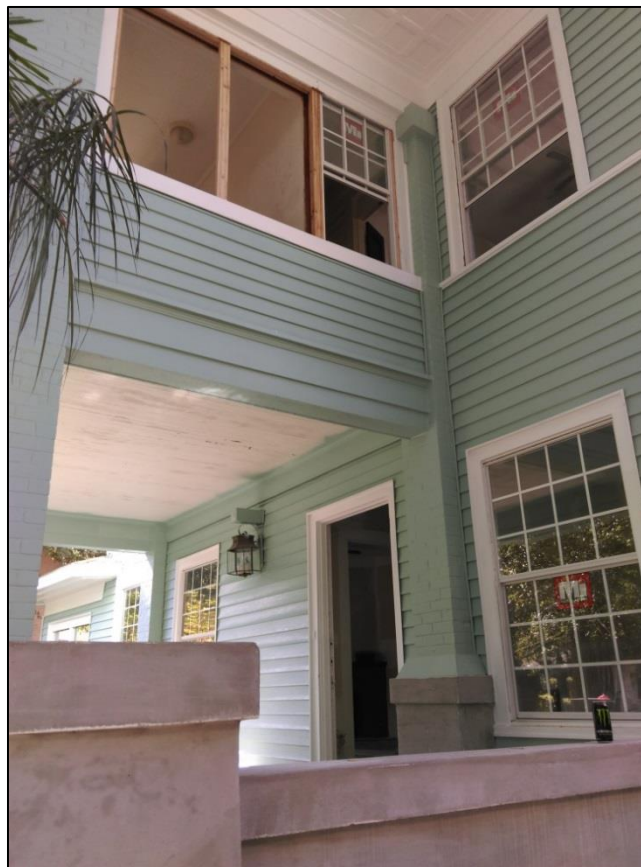
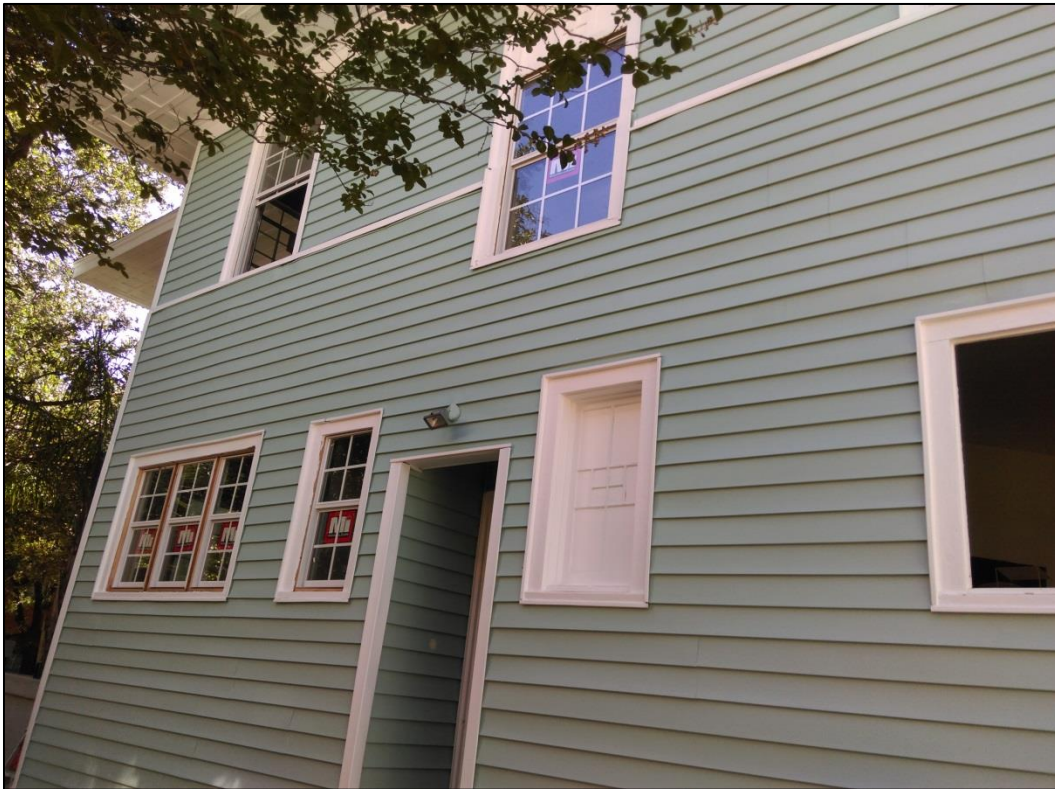
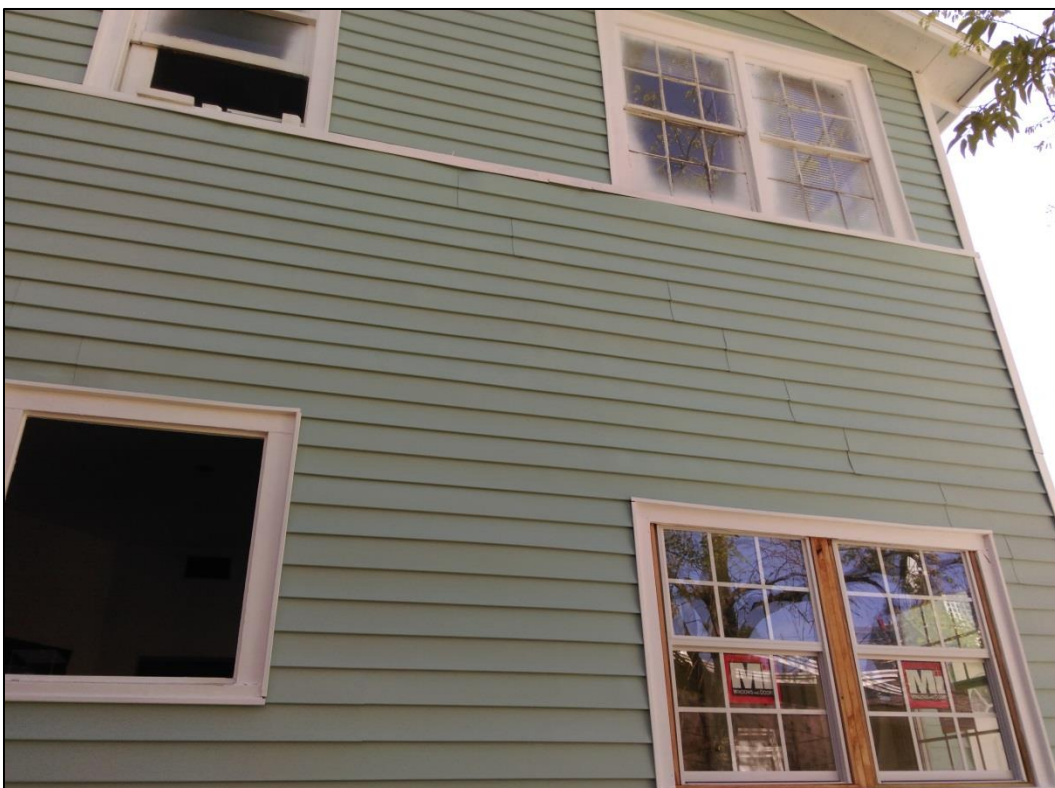
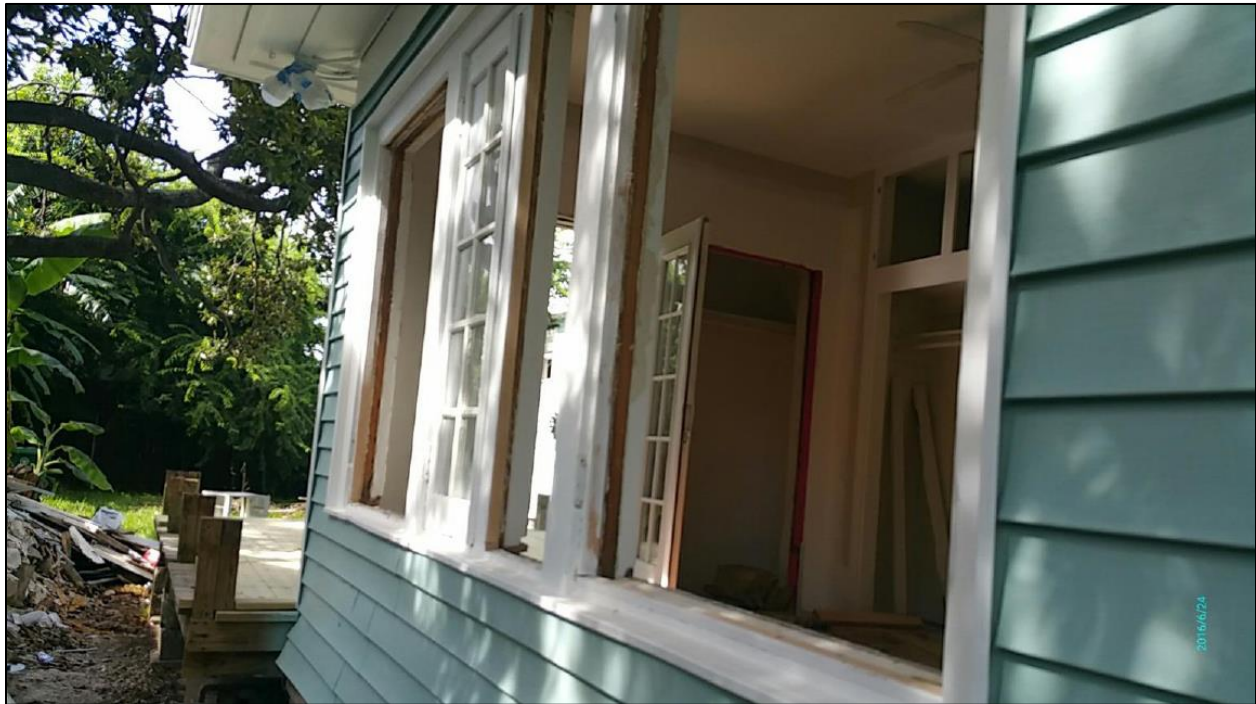
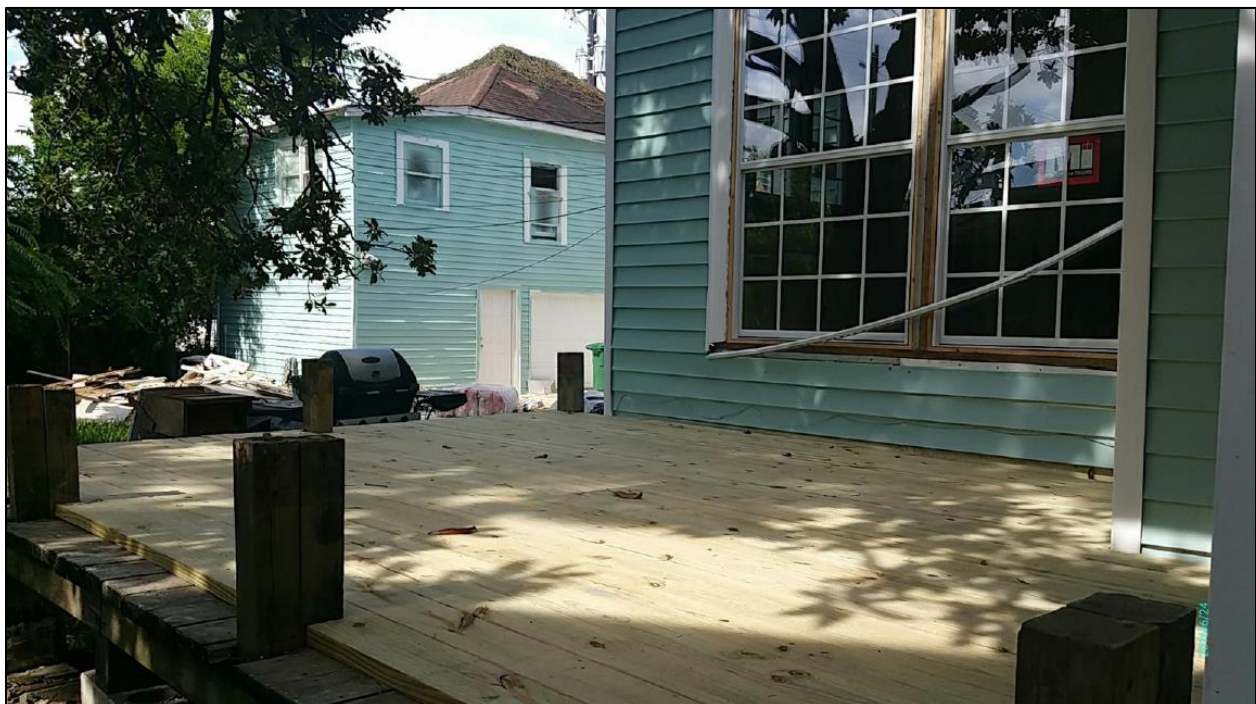
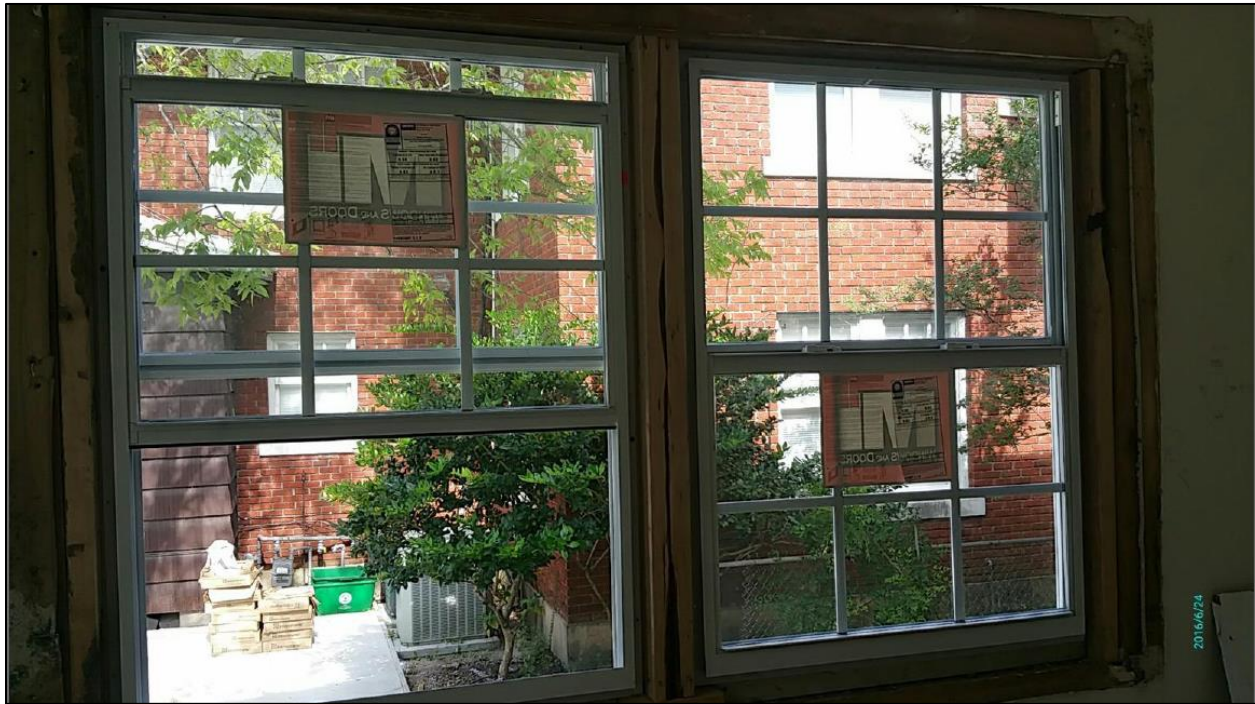
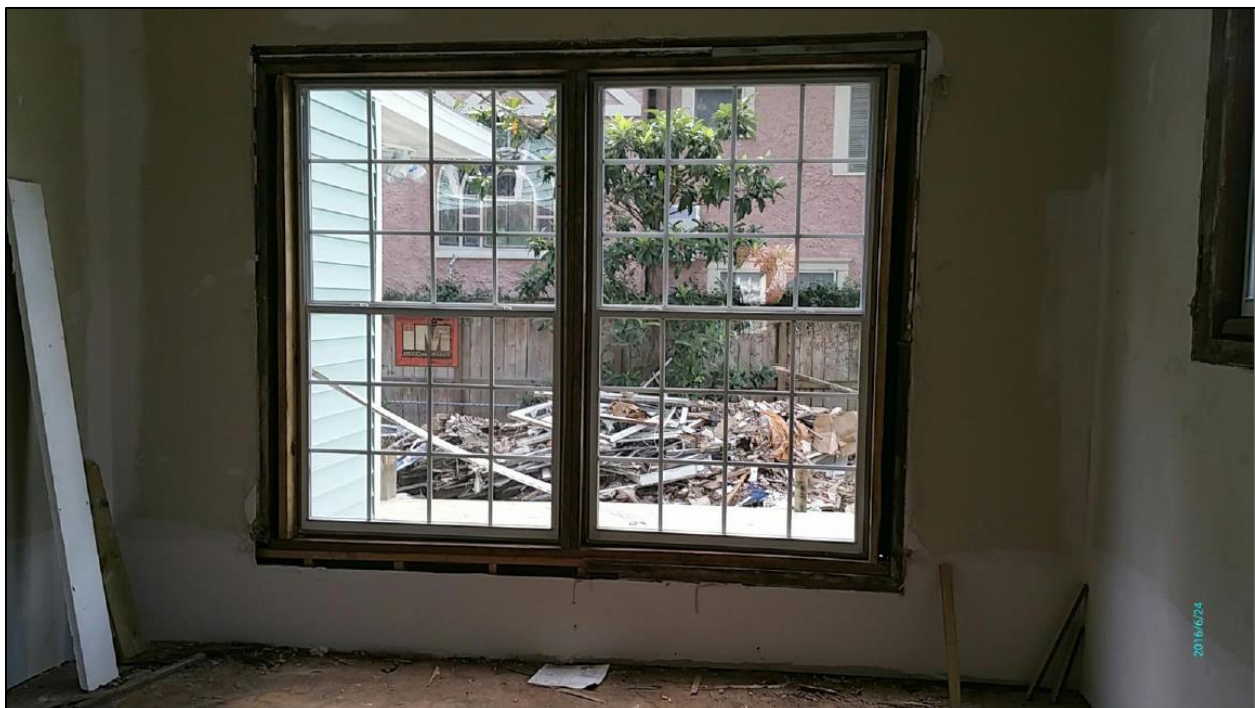
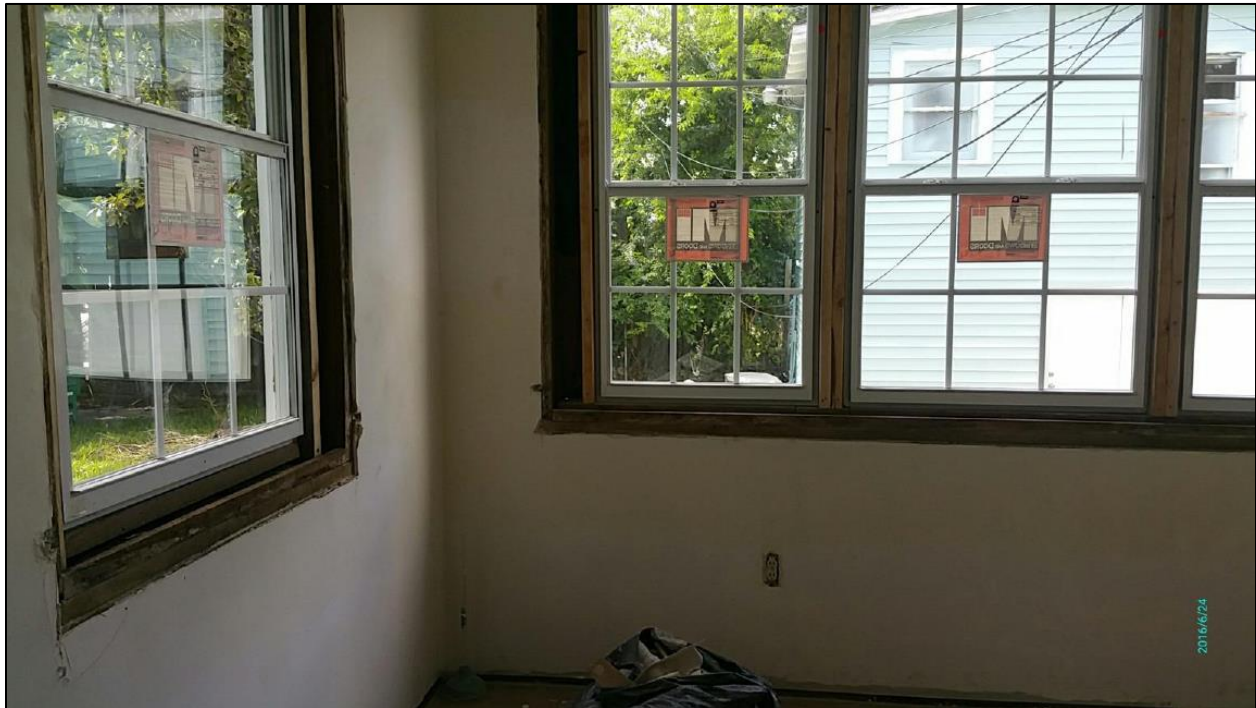
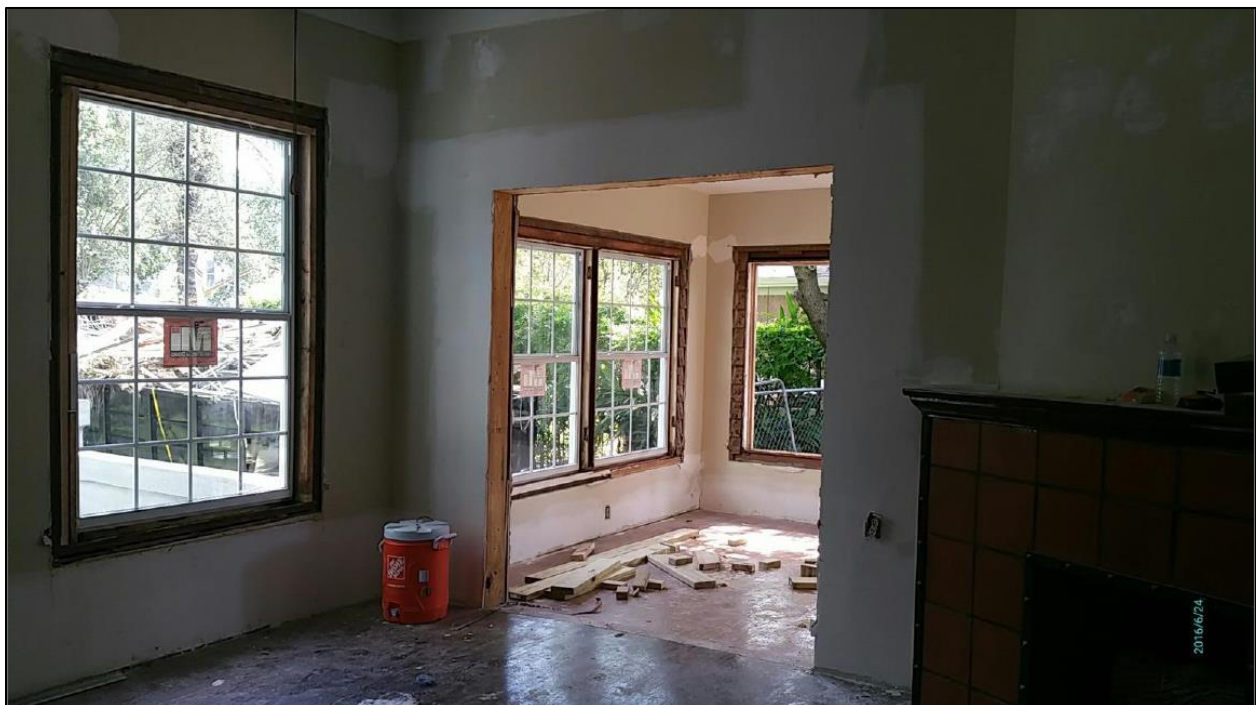
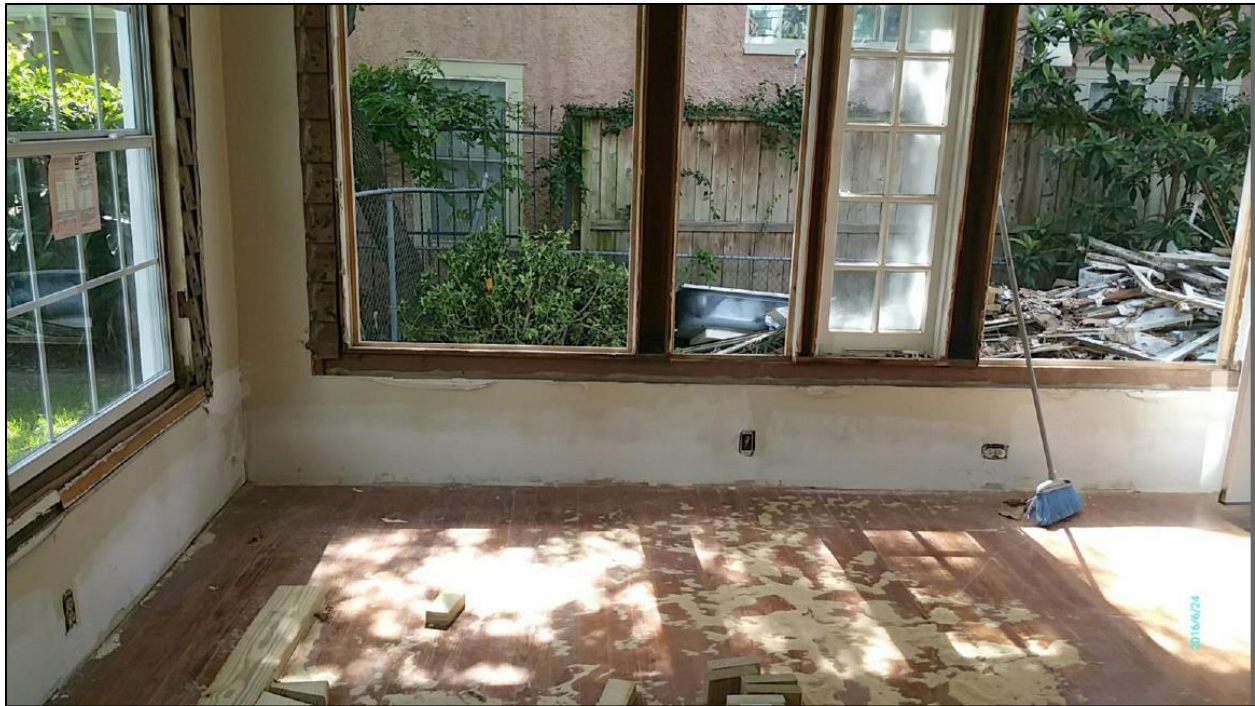
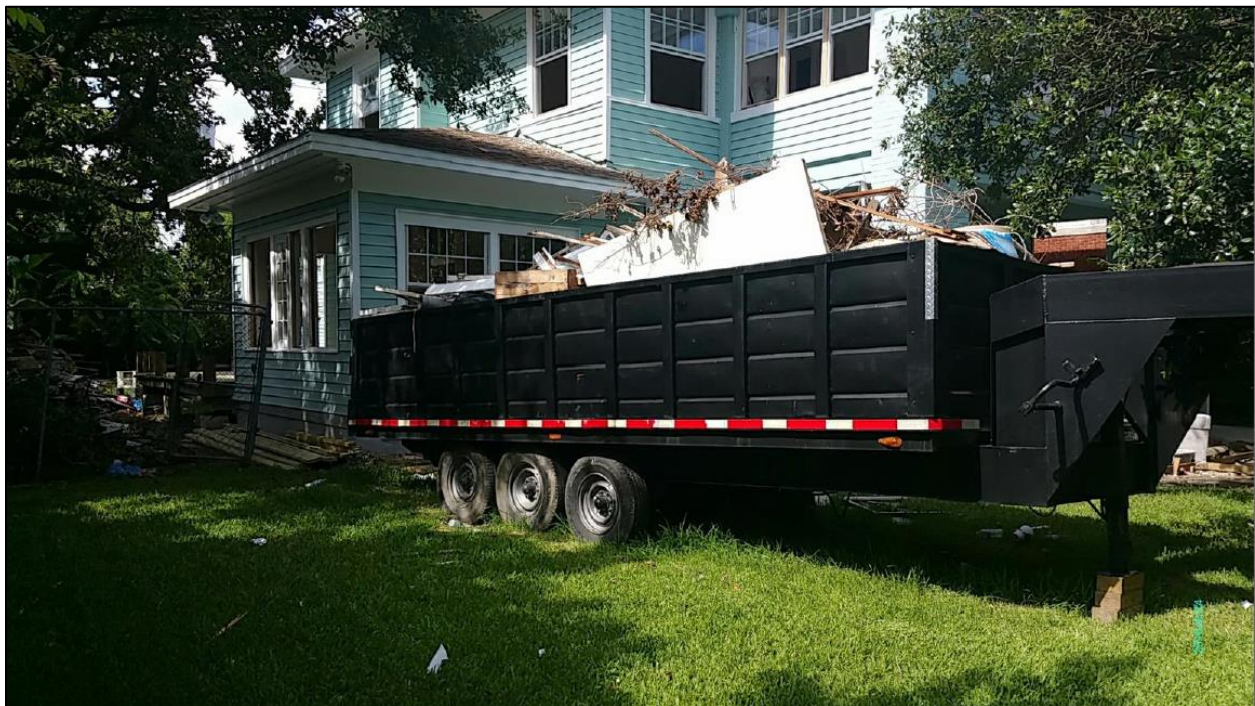
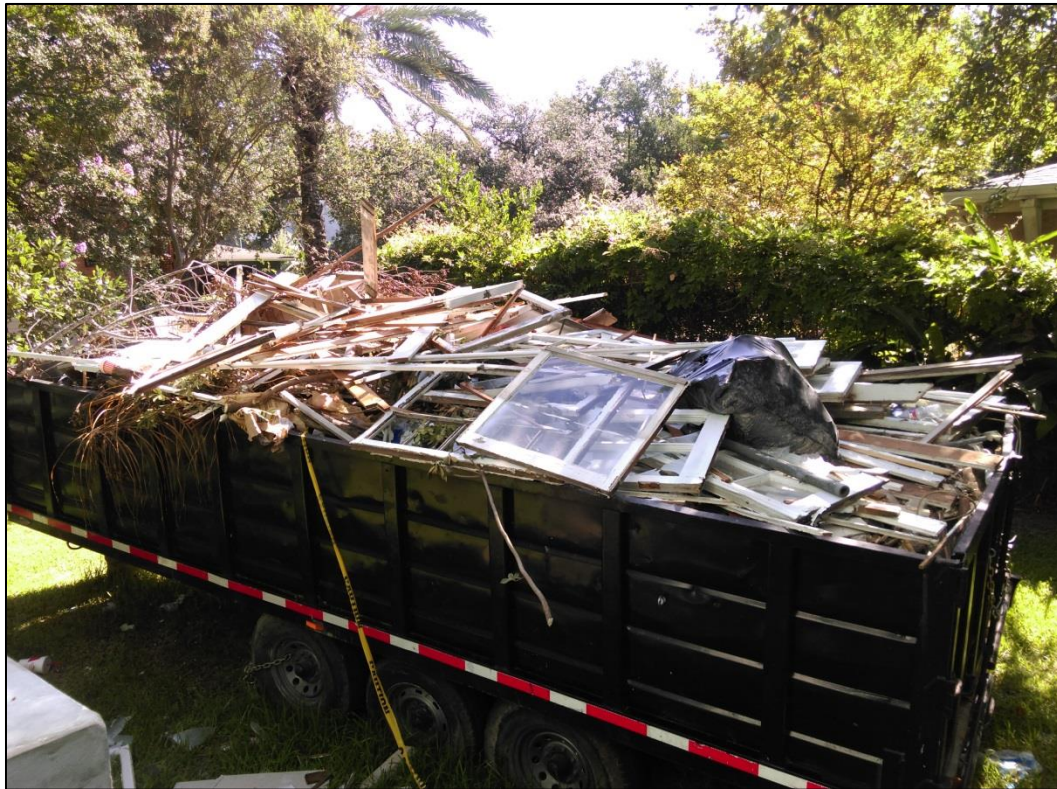
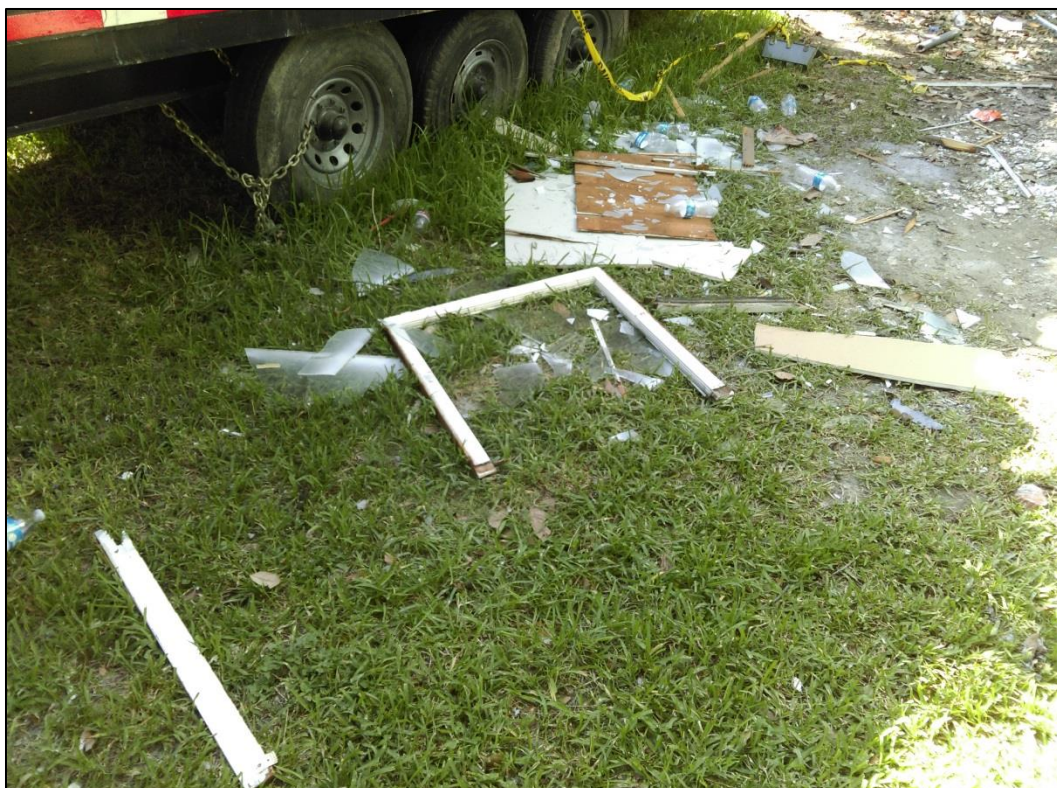
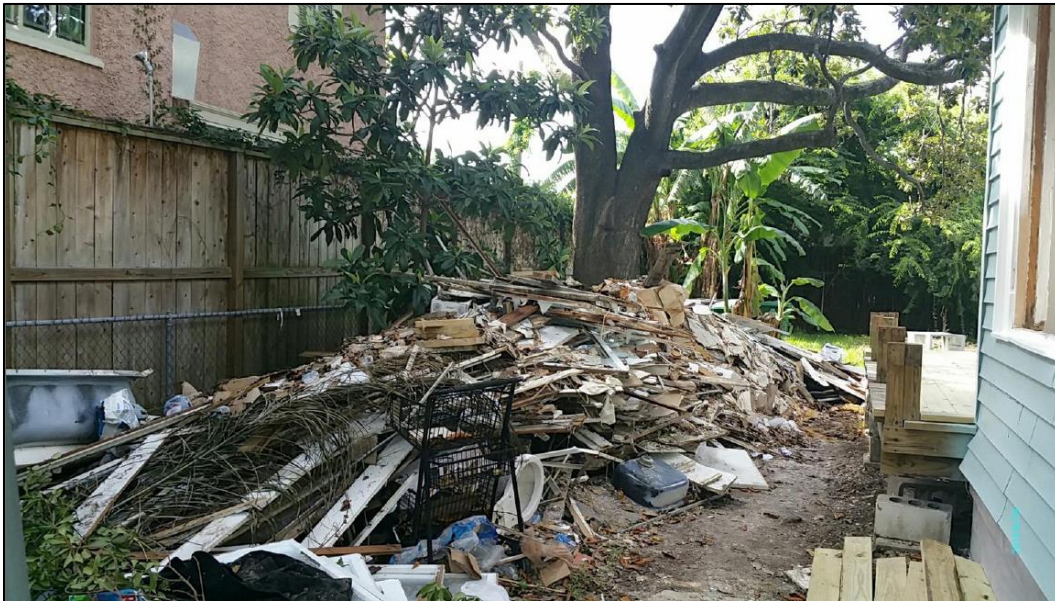
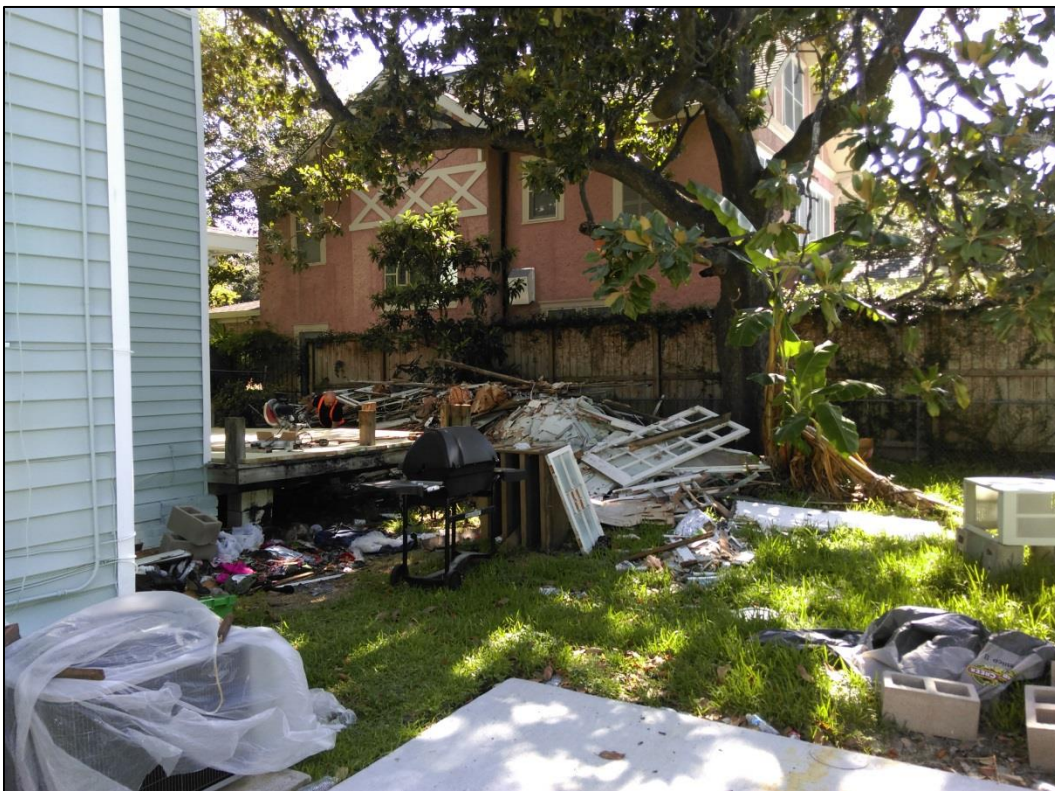
STAFF PHOTOS – JUNE 23, 2016

June 23, 2016: Staff arrived on-site finding numerous original windows removed and replaced. The original windows were located in a pile of construction debris. Staff issued a Red Tag and instructions to stop all unpermitted work, secure and dry-in the building, and to salvage and protect all original windows.

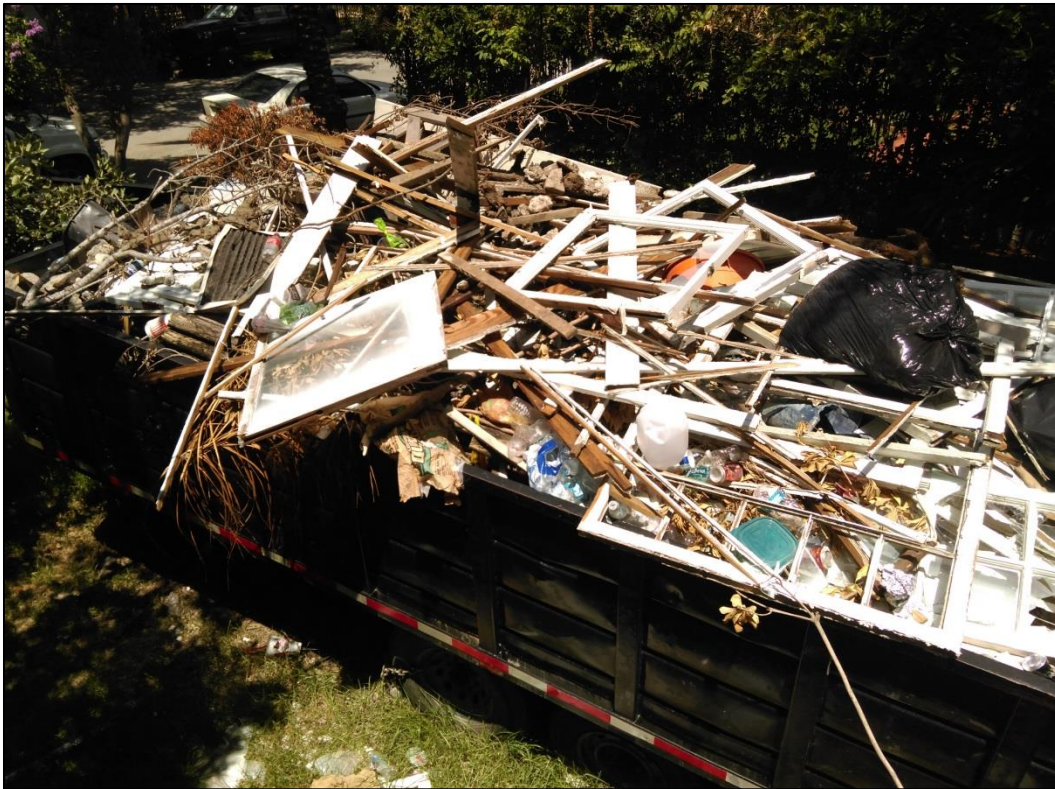
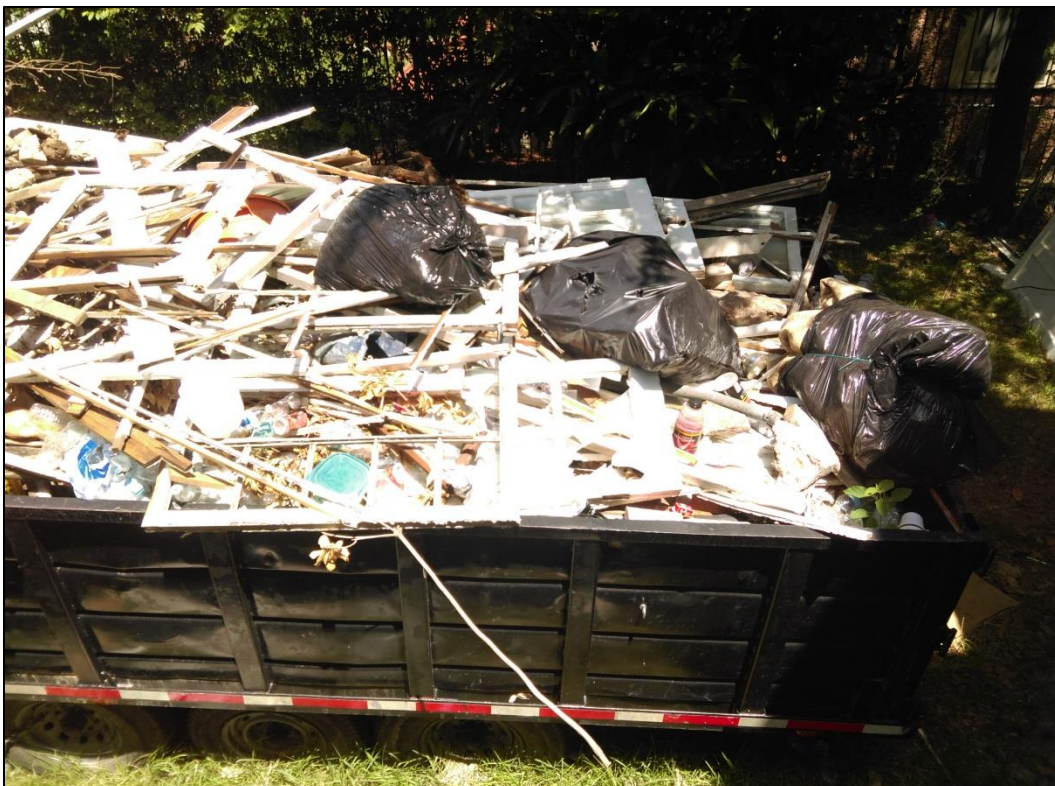
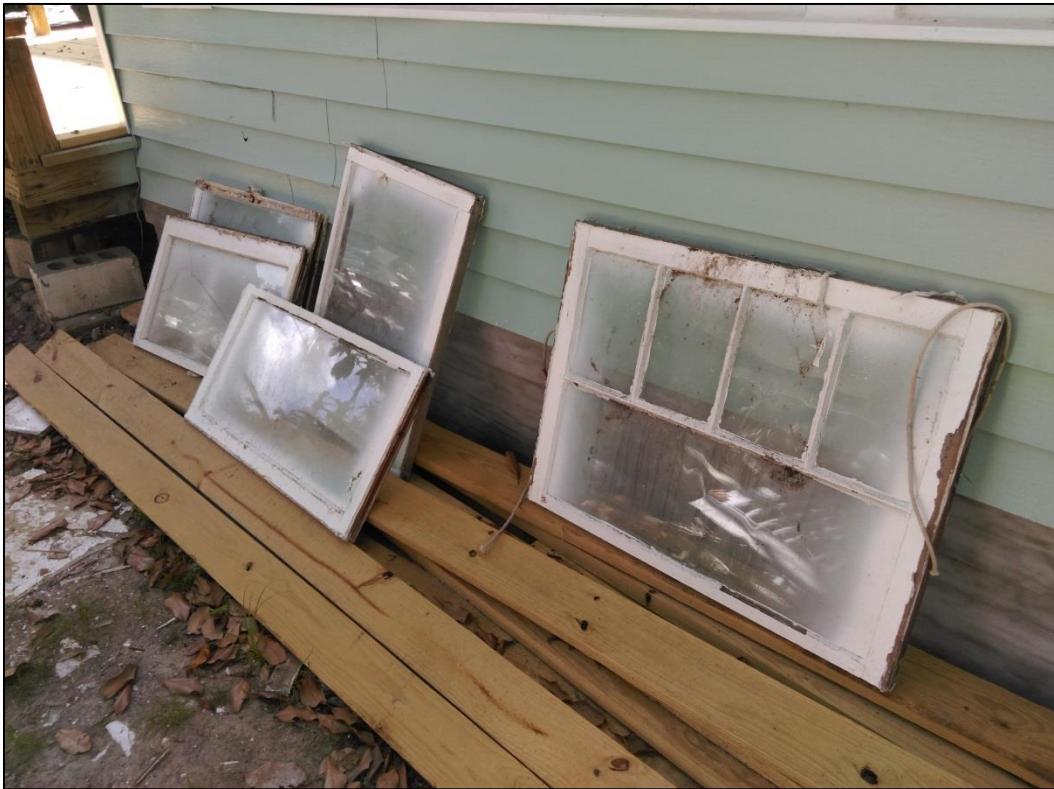
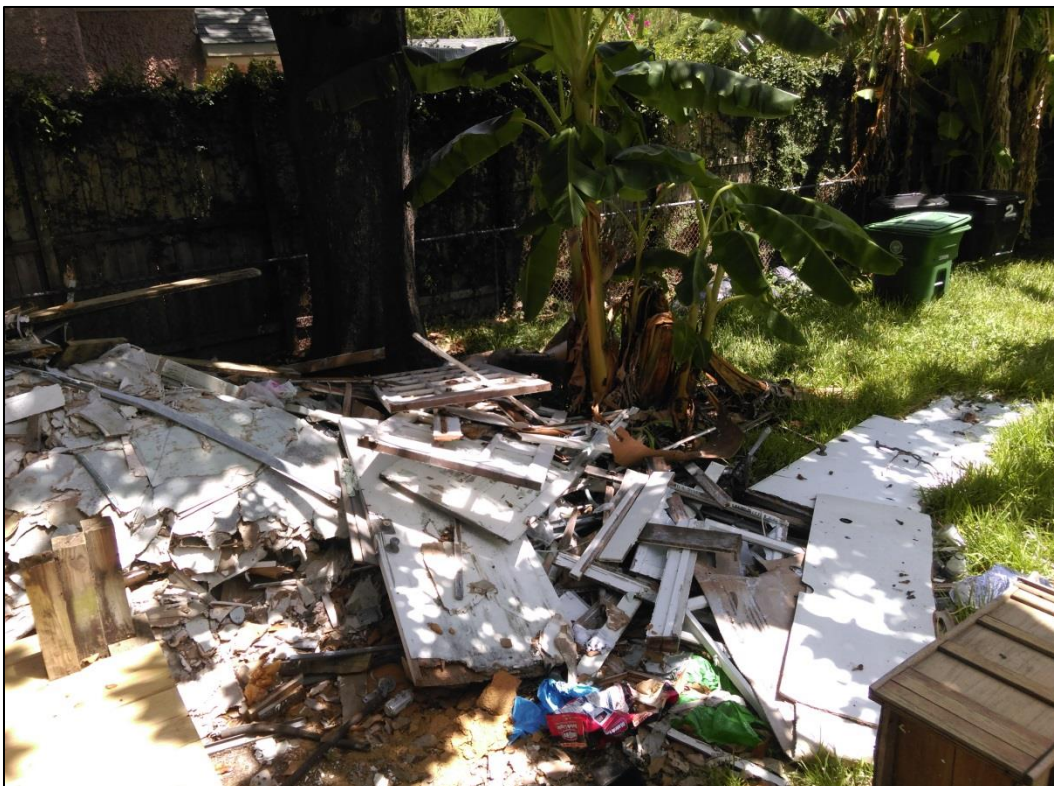
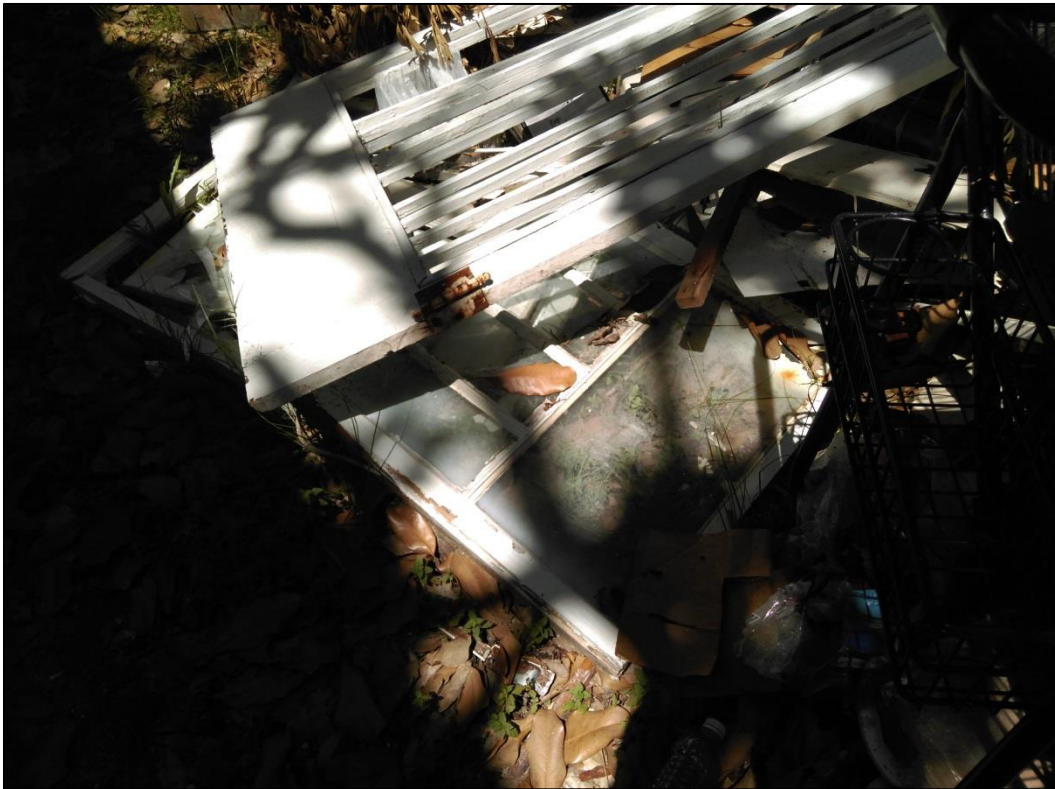
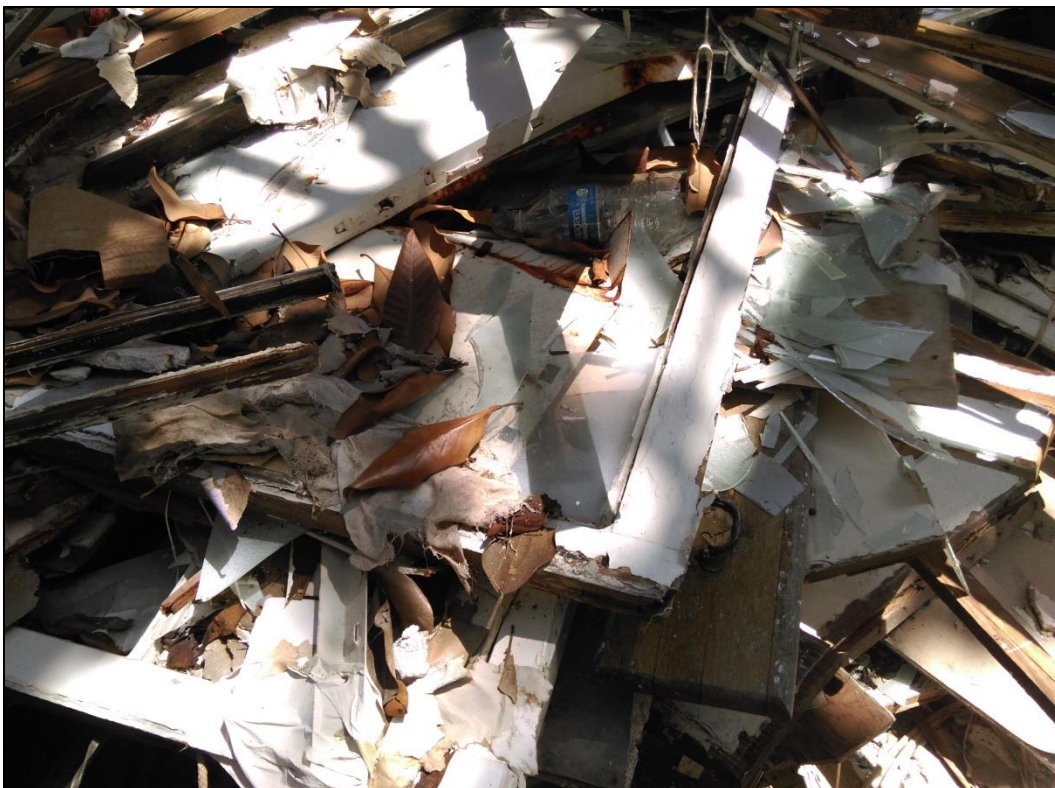
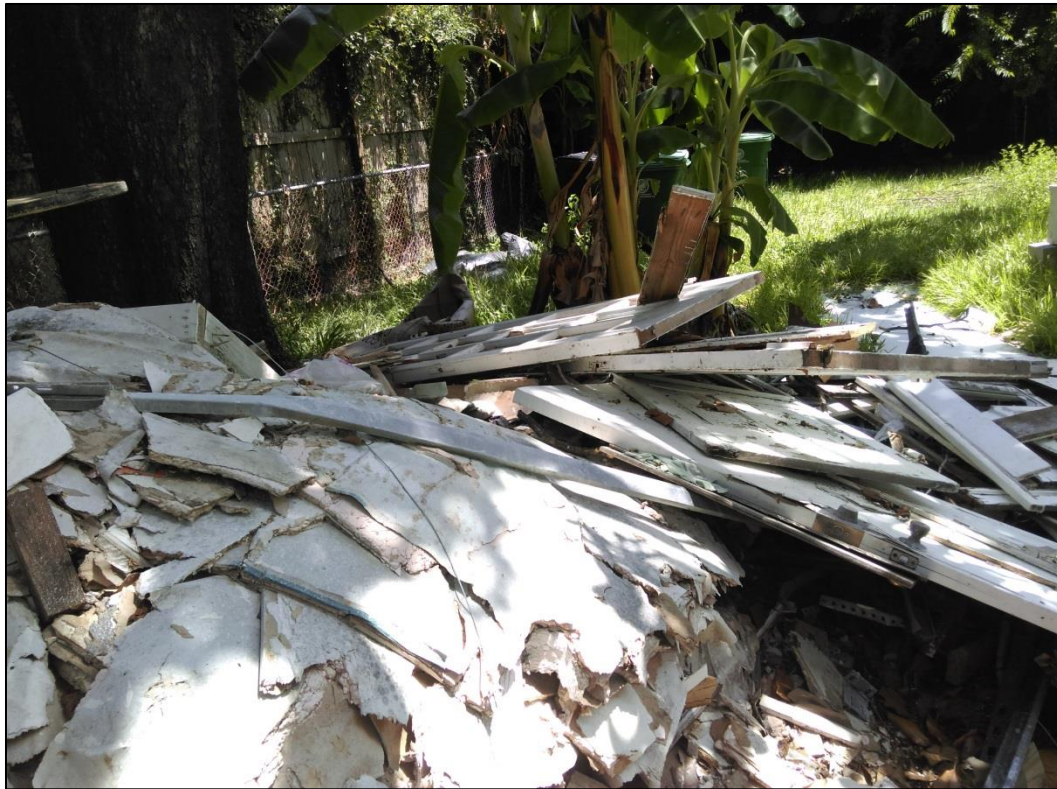
STAFF PHOTOS – AUGUST 9, 2016

August 9, 2016: Staff revisited the site and found the original windows still located in a pile of construction debris. Several windows had been removed from the piles, but were left outside, propped against the house, and not protected from the elements. Because the applicants have not removed the other windows from the pile, staff is unable to determine whether they are salvageable.

The plans submitted to staff indicate that only 8 of the 30 discarded windows will be salvaged for reinstallation. However, the applicants have not provided staff with any substantive proof that the other 22 historic windows, still in the discard piles, are damaged beyond repair. If these discarded windows are in salvageable condition, they become more deteriorated with every passing day, especially given the recent weather, by being strewn in piles exposed to the elements. Therefore, staff finds the installation of all new windows to be inappropriate. Staff recommends the applicants salvage the historic windows from the discards piles for reinstallation.

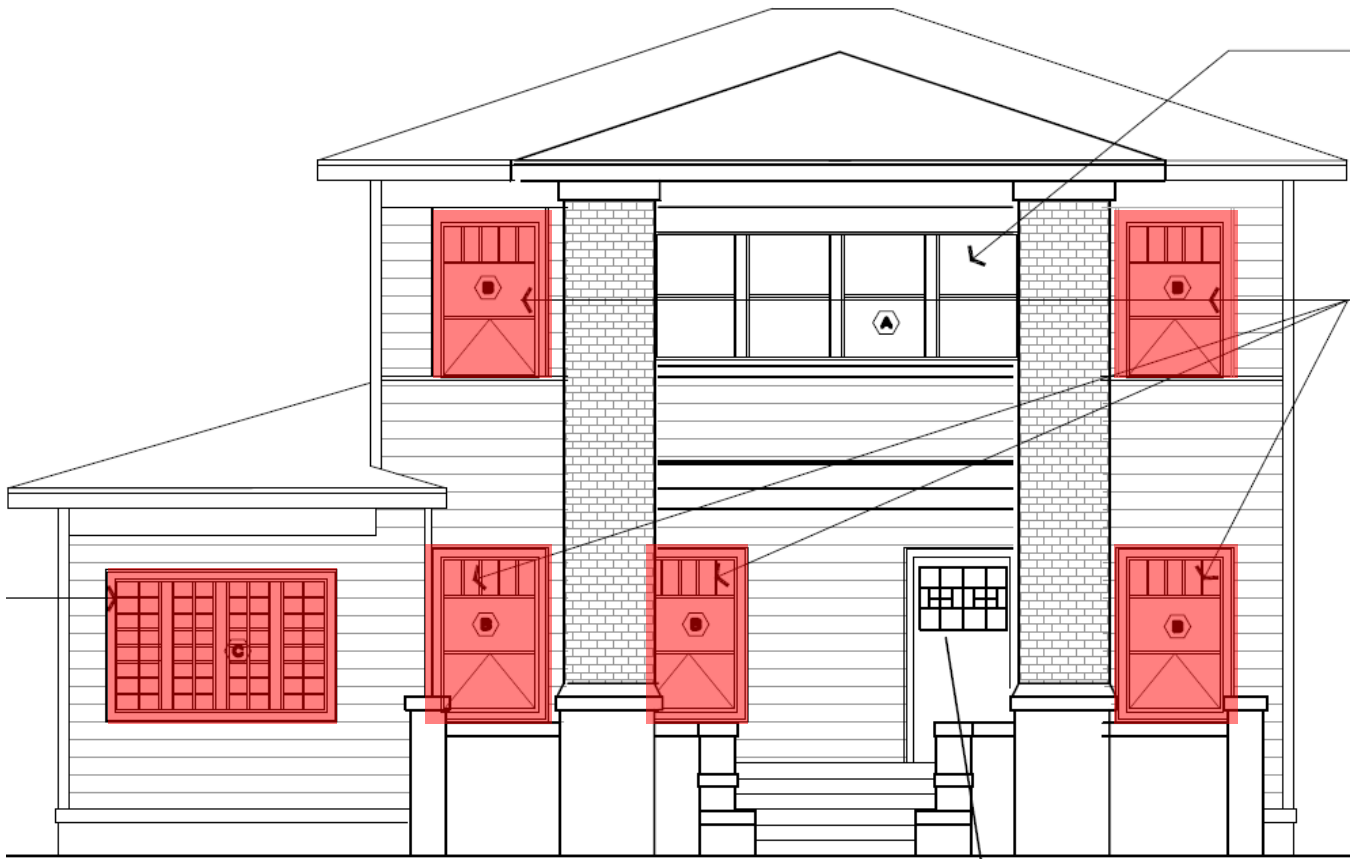
NORTH ELEVATION – FRONT FACING AVONDALE

Original windows removed;
proposed to be replaced with
replica wood windows

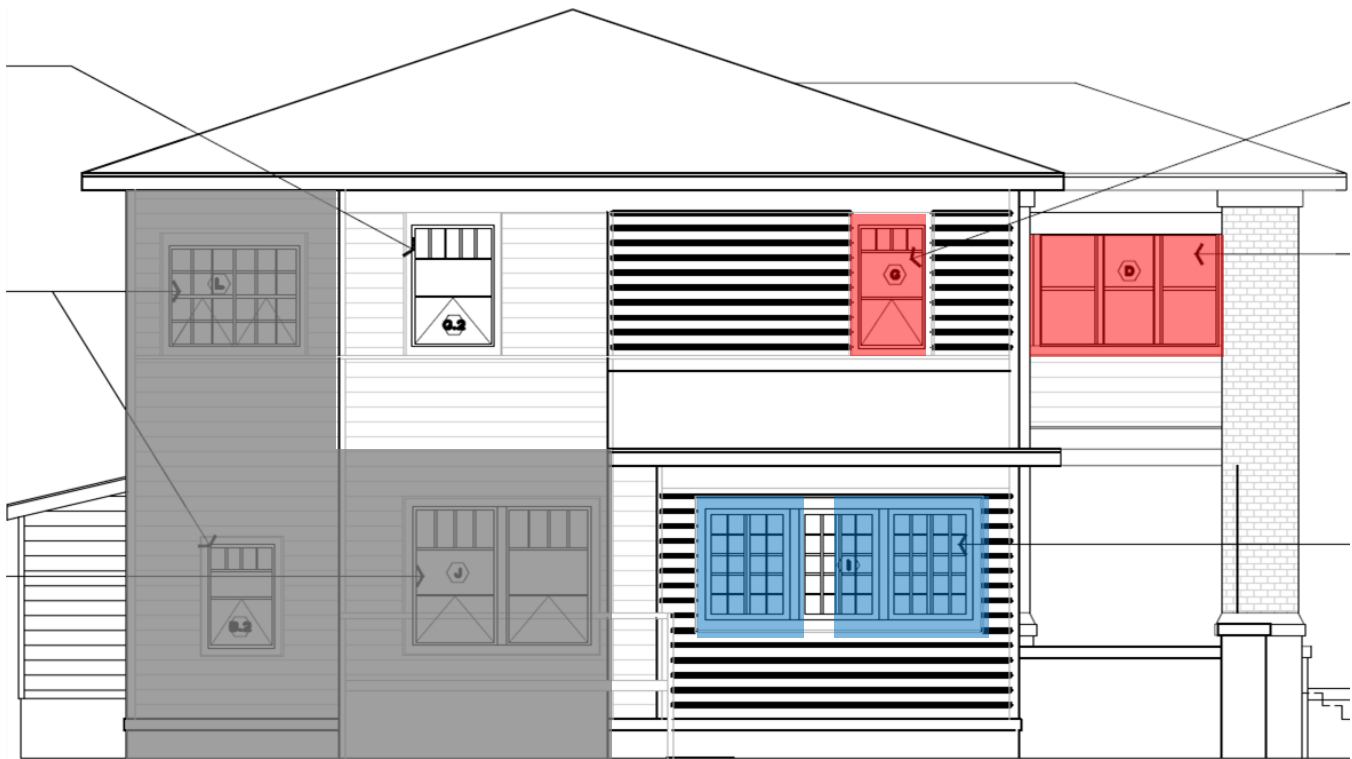
EAST SIDE ELEVATION

Original windows removed;
proposed to be replaced with
replica wood windows

Original windows removed; to be
salvaged and reinstalled

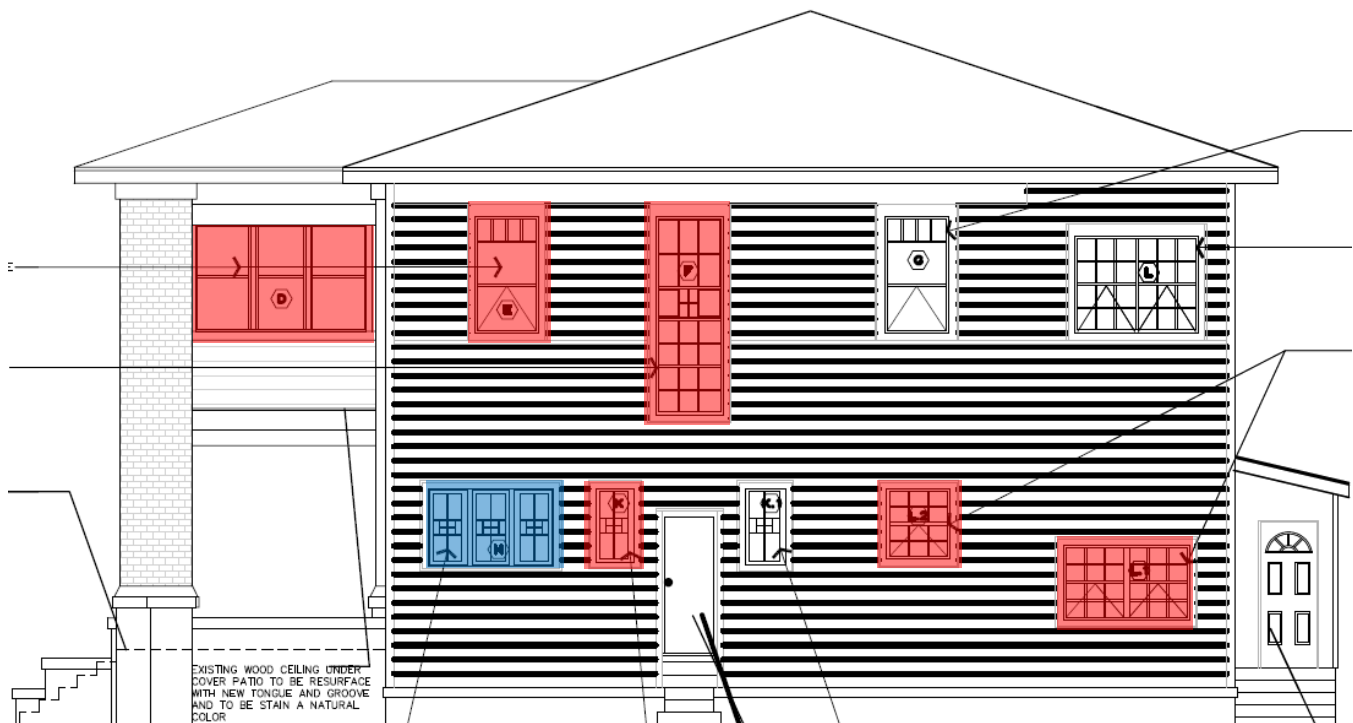
WEST SIDE ELEVATION

Original windows removed; proposed to be replaced with replica wood windows

Original windows removed; to be salvaged and reinstalled

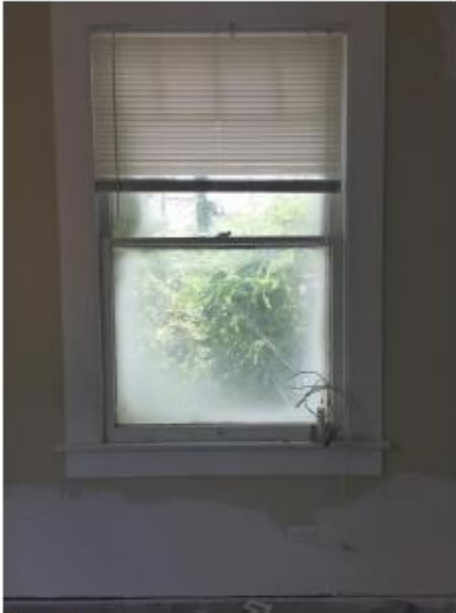
Figure 1

non- operable window

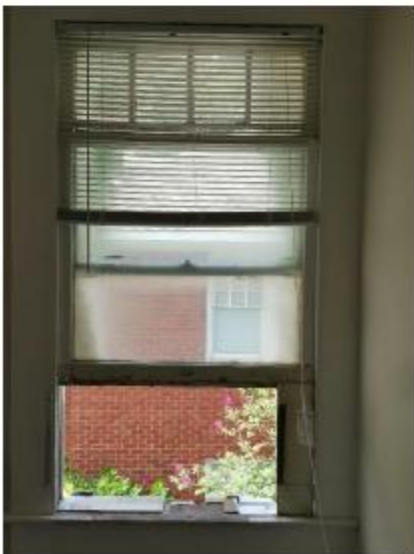
Figure 2

Missing glass, broken hardware, cannot be operable
